Stability Analyses of the 1981 San Luis Dam Slide

ABSTRACT: *The 1981 upstream slope failure in San Luis Dam in California, USA, is analyzed for stability and deformations in two- and three-dimensions using continuum-mechanics-based analysis procedures implemented in the computer programs FLAC and FLAC3D. The analysis results (failure surface, factor of safety, and displacements) from the continuum models are in general agreement with the field data. In addition, two-dimensional slope stability analysis results using a modified form of limit-equilibrium-based Spencer's procedure for variable factor of safety implemented in the computer program SSTAB2 are included. Overall, the analysis results supplement the previously reported failure analyses. The paper serves three primary functions: (1) it documents results of a different analysis of the 1981 San Luis Dam slope failure; (2) it demonstrates the use of 2-D and 3-D continuum models to study the onset of instability, failure surface geometry and location, and permanent displacements associated with slope failures; and (3) it demonstrates the use of variable factor of safety to identify location of instability initiation, and progr

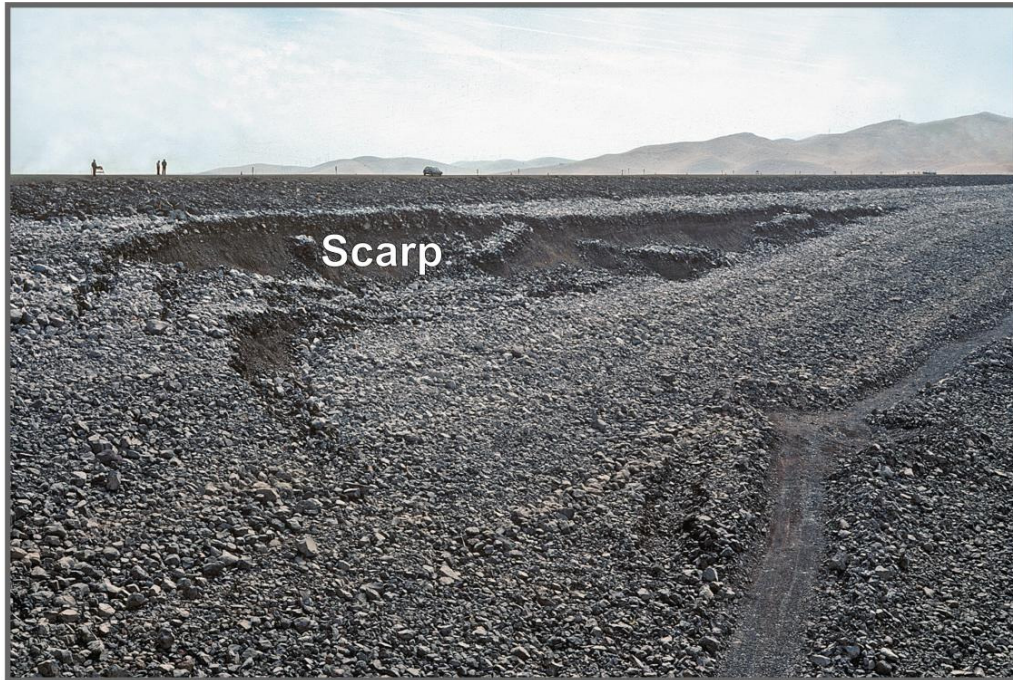
Figure 1. San Luis Dam site: (a) Elevation view of the 1981 slide; (b) Reservoir operational history.

2. Observations of the 1981 slide: The following field observations of the slide were noted by VonThun (1985) – see Figures 1(a), 2, and 3: First cracking occurred about 30 m (100 ft) down the u/s slope near the crest of an enveloped hill (near station 135) and progressed down the abutment towards more voluminous cross sections. The characteristics and progression of the slide mass are summarized as: (a) began as an arc-shaped crack, with ends of the arc parallel and perpendicular to the dam axis; (b) progressed from the initial length of about 150 m (500 ft) to an ultimate length of about 450 m (1475 ft); (c) took about two months to fully develop and stabilize; (d) formed a distinct pressure ridge at the toe moving over a portion of the toe of the dam for a distance of about 10 m (30 ft); and (e) moved on the order of 20 m (65 ft) with a 15 m (50 ft) vertical scarp. In view of the size of objects in Figure 1(a), the 15 m (50 ft) dimension for the vertical scarp seems to be in error (an over-estimate) – it is listed as 7.6 to 9.1 m high in Penman (1986) and 10 m high in Duncan and Wright (2005).

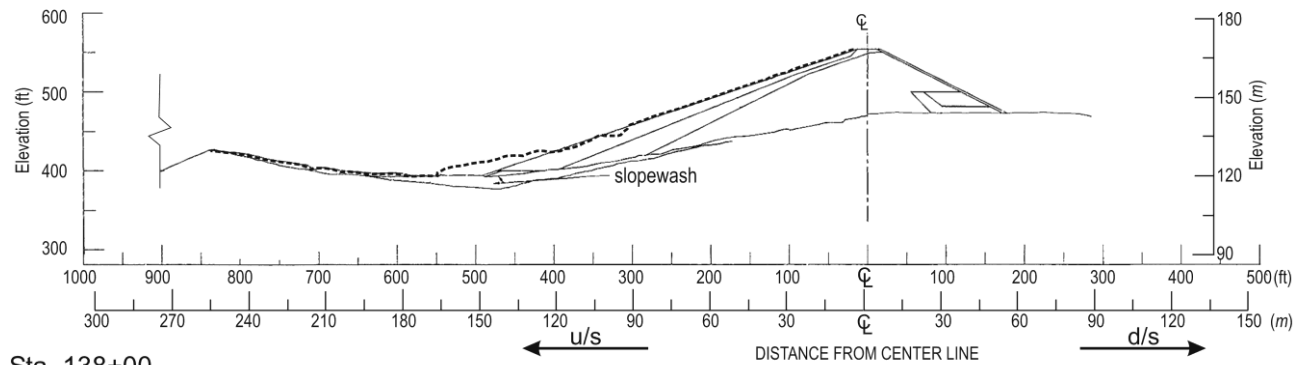
Figure 3. Cross section views of the San Luis Dam from station 120 to station 138 showing the original and deformed configuration of the dam.

Sta. station; \odot Dam zone no. for $i = 1$ to 5; β_i natural ground slope angle for $i =$ Sta. 120 to Sta. 138

The dam zones are identified on cross section at Station 120 in Figure 3, the same zoning identification applies to all cross sections included in this figure. All materials were placed in lifts and compacted with appropriate equipment typical of the period (1963 - 1967).

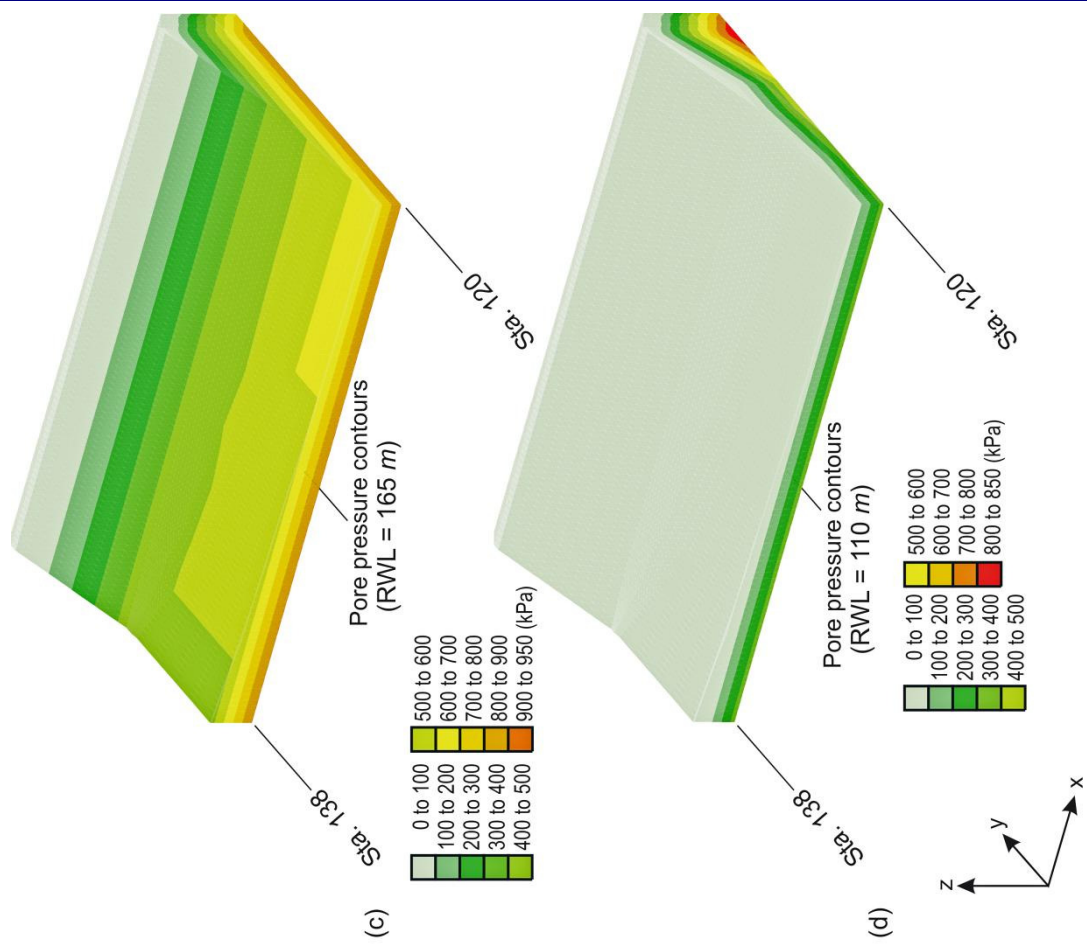
Figure 5. Reservoir water level and associated phreatic surface/pore pressure contours in the reach of the slide (used in 2- and 3-D analyses): (a) RWL = 165 m (540 ft), cross section at station 120; (b) RWL = 110 m (360 ft), cross section at station 120; (c) RWL = 165 m (540 ft), perspective view from station 120 to Station 138; (d) RWL = 110 m (360 ft), perspective view from station 120 to Station 138.

- ↓ ↓ Reservoir water pressure
- RWL = 165 m corresponds to RWL = 540 ft
- RWL = 110 m corresponds to RWL = 360 ft
- △ *i* Material ID for *i* = 1 to 5 (Table 1)

Two reservoir water level conditions of interest are (a) steady-state RWL = 165 m (540 ft) and (b) rapid-drawdown RWL = 110 m (360 ft). For RWL = 165 m, the phreatic surface was estimated from the available instrumentation data prior to the 1981 slide and calibrated 2-D finite-element-based seepage analyses of dam cross sections outside the reach of the 1981 slide (Mantei, 1982). For RWL = 110 m, the phreatic surface was assumed (due to lack of instrumented data) to rise from elevation 110 to elevation 165 along the interface between the shell and core and then follow the steady-state phreatic surface (Lamb and Whitman, 1969). Reservoir water pressure on the upstream face of the dam corresponds to the RWL condition being considered in the analysis. For illustration, Figure 5 shows the two reservoir water level conditions and associated phreatic surfaces for the cross section located at station 120; spatial layout of the reservoir and associated phreatic surface from station 120 to 138 are shown as pore pressure contours. Reservoir water loading conditions vary along the length of the slide due to changes in the ground elevations. For the RWL = 110 m condition, in locations where ground elevation is higher than elevation 110 m, there is no surface pressure due to the reservoir water.

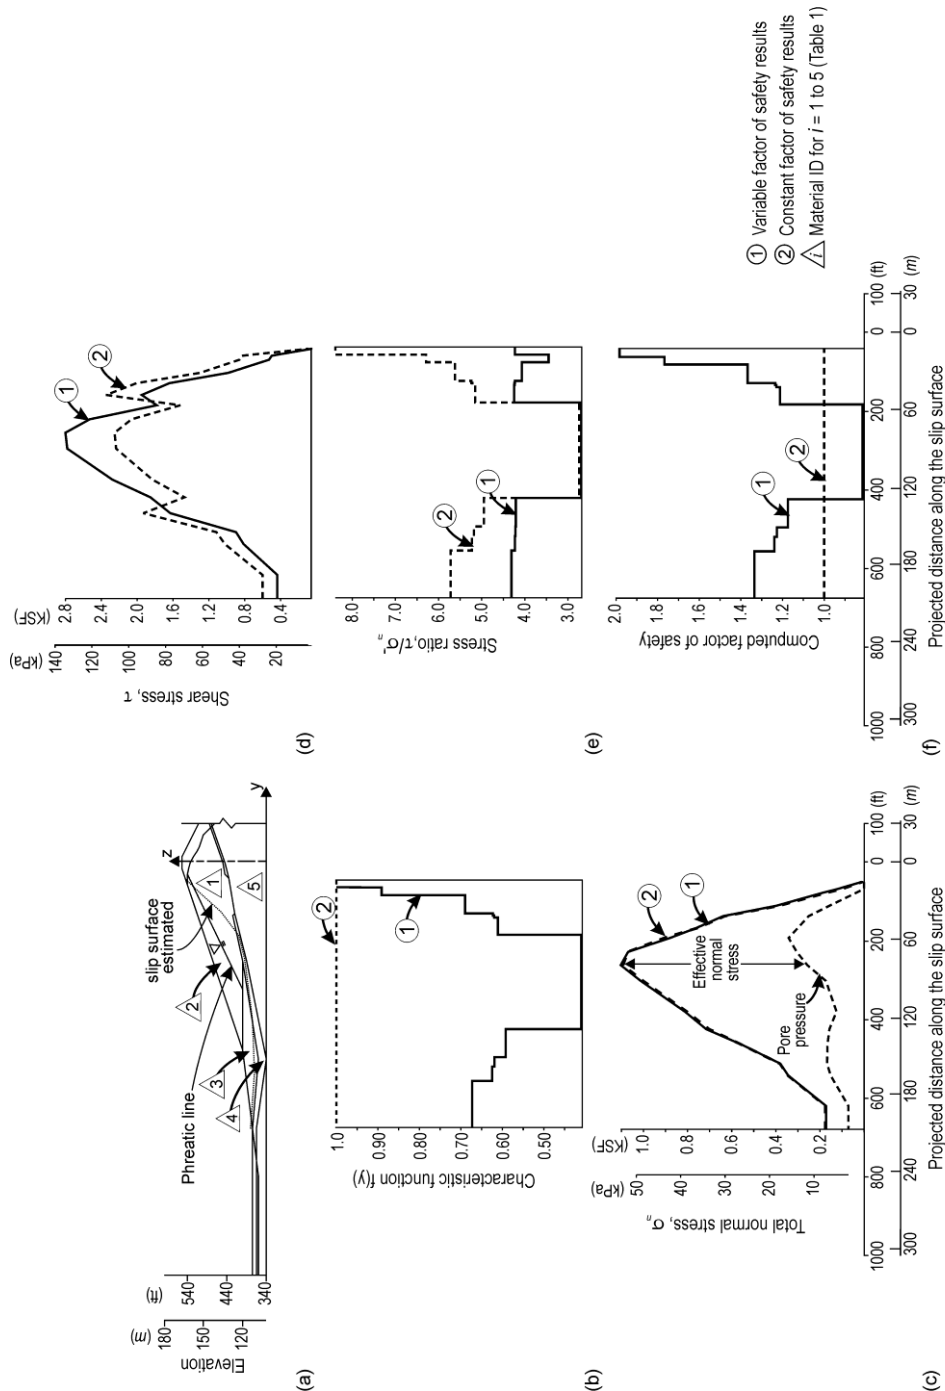
Figure 6. Limit-equilibrium based slope stability analysis results for constant and variable factor of safety for the cross section at station 135. Reservoir water level is 110 m (360 ft), angle of internal friction for slopewash is 15° , and the slip surface geometry is estimated from the post-failure field data (Stark and Duncan, 1991): (a) Cross section at Station 135; (b) Normal stress (σ_n) along the slip surface; (c) Characteristic function $f(y)$ description; (d) Shear stress (τ) along the slip surface; (e) Stress ratio (τ/σ'_n) along the slip surface; (f) Factor of safety along the slip surface.

1. *Variable factor of safety:* Figure 6(a) shows the model and the analysis results. The computed value of scalar parameter λ is 1.983. The average value of F is 1.005. The constant value of F is 0.99. Significant observations from the results shown in Figure 6 include:

- The factor of safety in the slopewash is 0.81 whereas it is greater than unity in other materials along the slip surface. This result suggests that the slope instability initiated in the slopewash material underlying the embankment.

- The factor of safety near the toe of the slide is about 1.3 and it is about 2.0 near the crest of the dam. This suggests that the slope instability progressed towards the toe from the slopewash; this should have resulted in a depression on the u/s slope immediately above the slopewash with $F = 0.81$ as noted in observation (a).

- Observation (b) is manifested by formation of cracks near the crest of the dam that occurred due to failure of the active wedge (sloping at about 45° through the zone 1 material) after the slope instability had initiated and progressed towards the toe, and F for the active wedge dropped from about 2.0 to just less than unity. Thus the formation of cracks occurred after the sliding mechanism was complete and the slide movement had initiated. This observation suggests that remediation of cracks would not have prevented the slope failure.

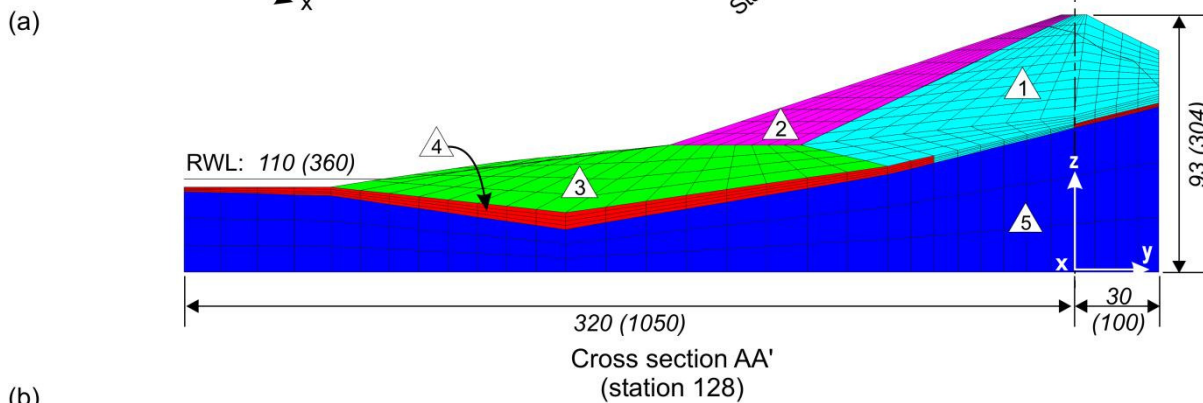
Figure 7. Numerical model of the San Luis Dam between stations 120 and 140: (a) Perspective view; (b) Cross section view at station 128; (c) Reservoir water and pore pressure for RWL = 110 m (360 ft) at station 128.

Figure 7(a) shows the perspective view of the 3-D numerical model of the San Luis Dam between stations 120 and 138. Figures 7(b and c) show the cross section view of the model, the reservoir pressure loading, and the pore pressure contours for a cross section located at station 128 for RWL = 110 m (360 ft). The reservoir pressures shown in Figure 7(c) are modeled as nodal forces. The force vectors for the end-nodes are half as big as for the central nodes because the contributing area is half as big. The boundary conditions for the 2- and 3-D analyses are shown on Figure 7(a).
